DEBRIS/ICE/TPS ASSESSMENT  
AND  
PHOTOGRAPHIC ANALYSIS  
OF  
SHUTTLE MISSION STS-32R

January 9, 1990

Gregory N. Katnik  
NASA/Kennedy Space Center  
TV-MSD-22

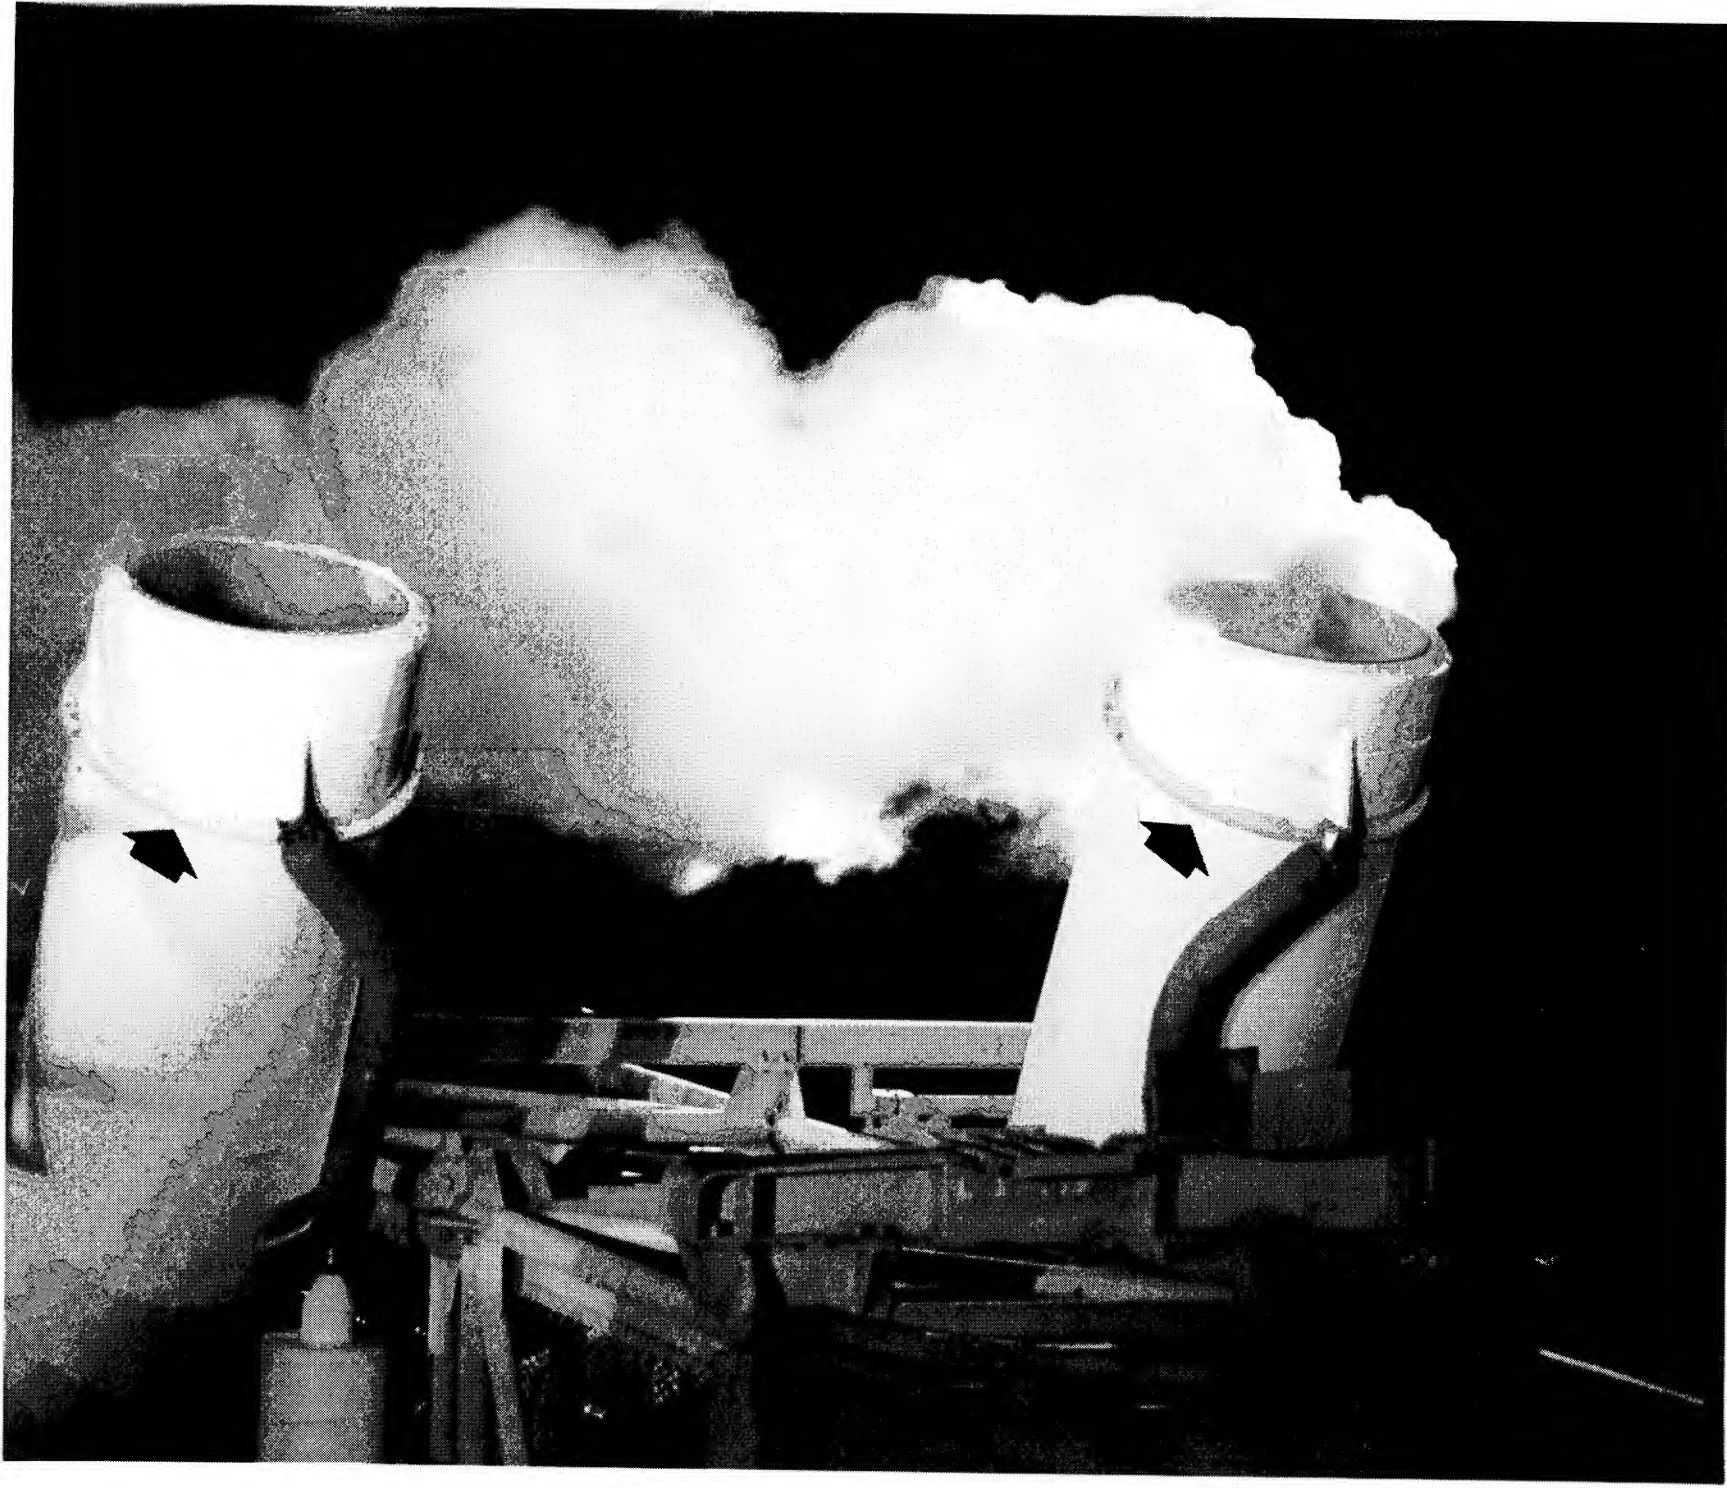
Installation of hydro diversers on the GOX vent ducts after the launch scrub precluded the formation of large icicles

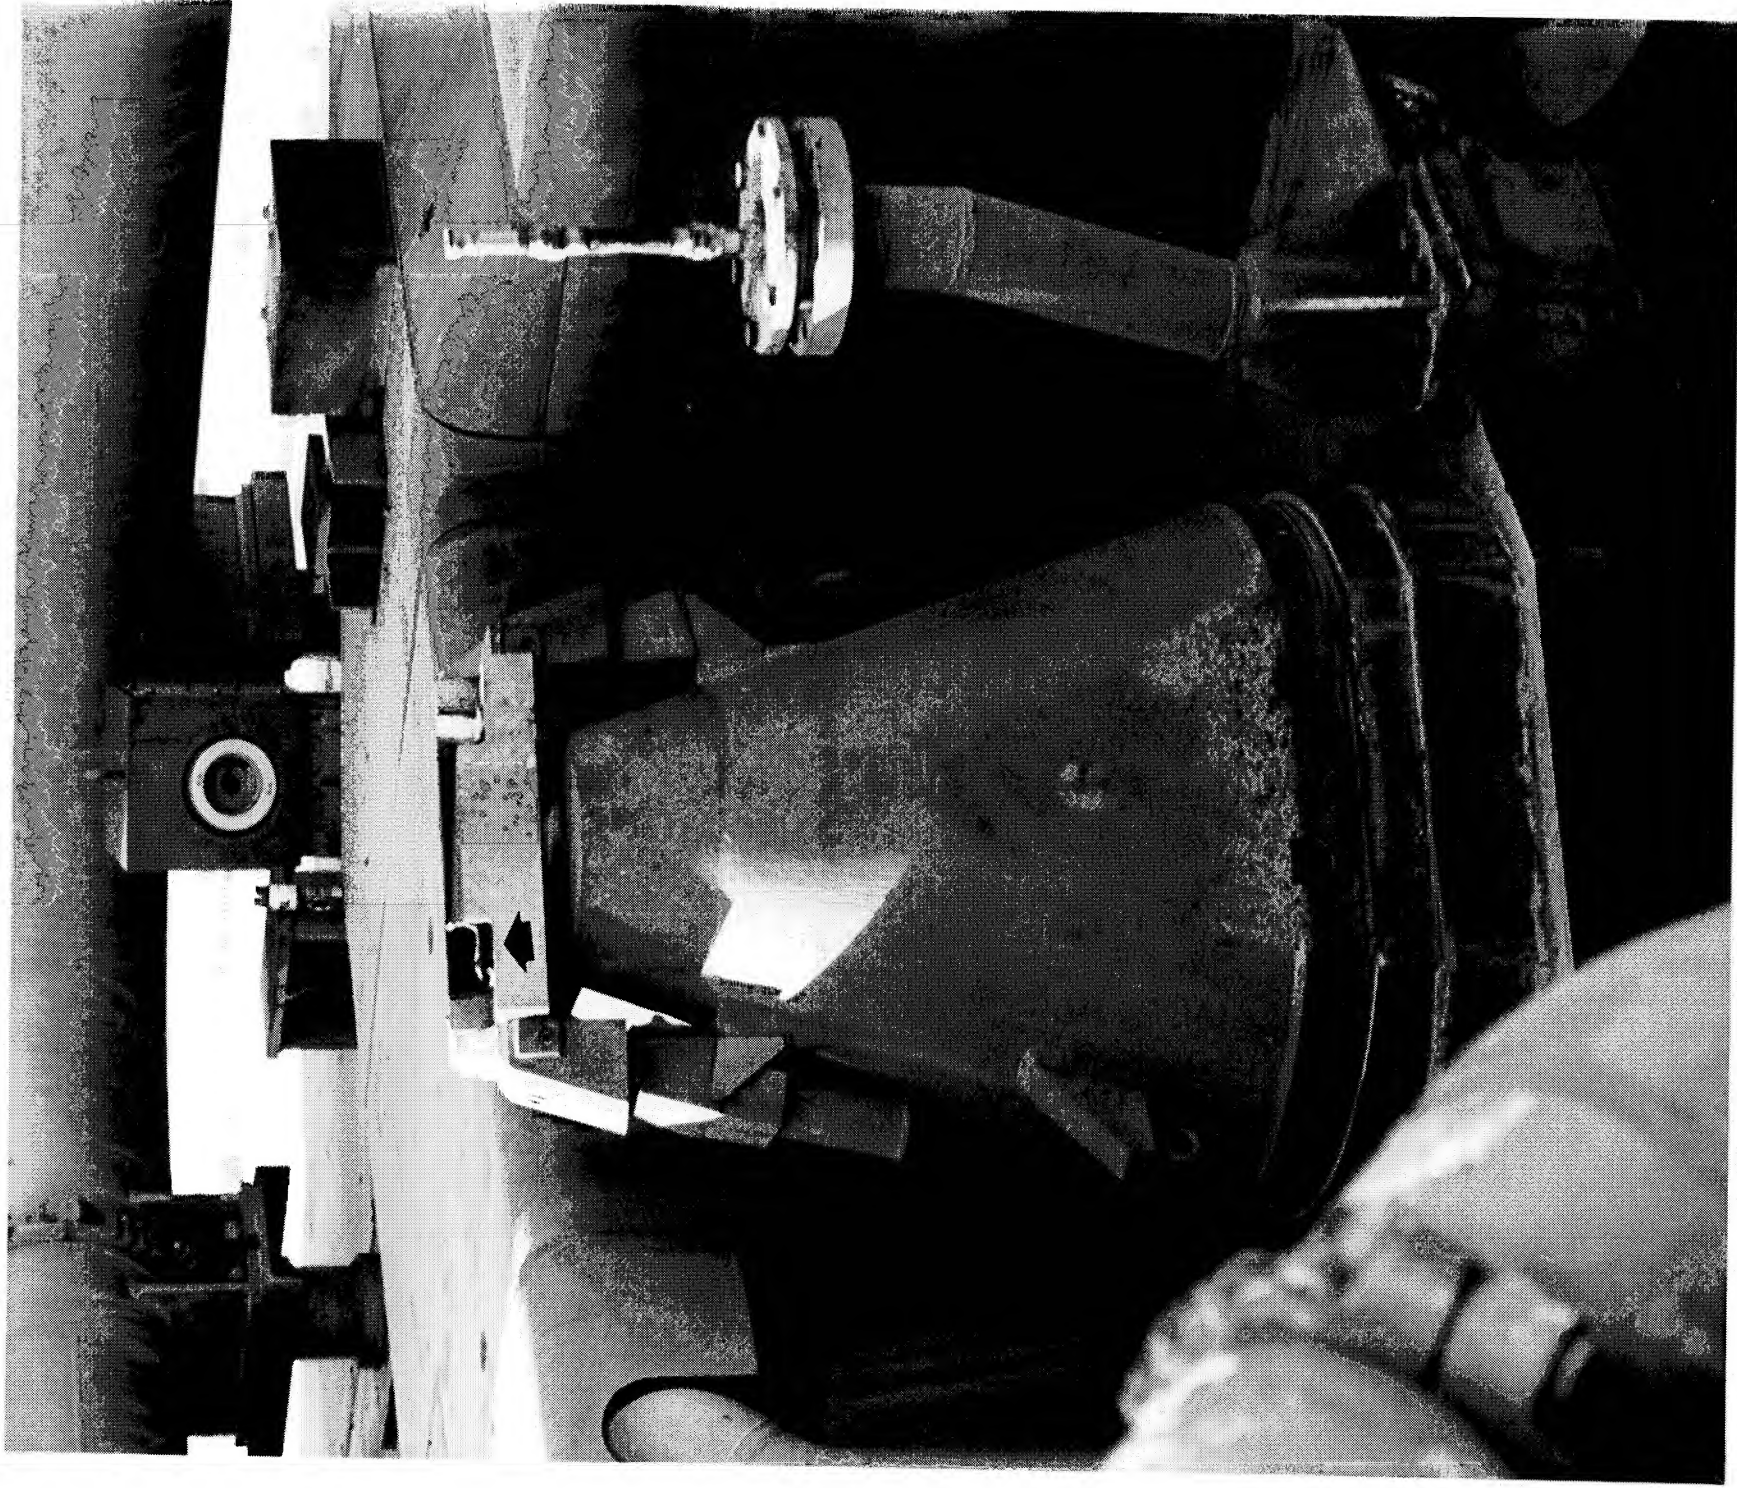
Post launch condition of a south SRB holddown post. Note debonded shim on the holddown post shoe.

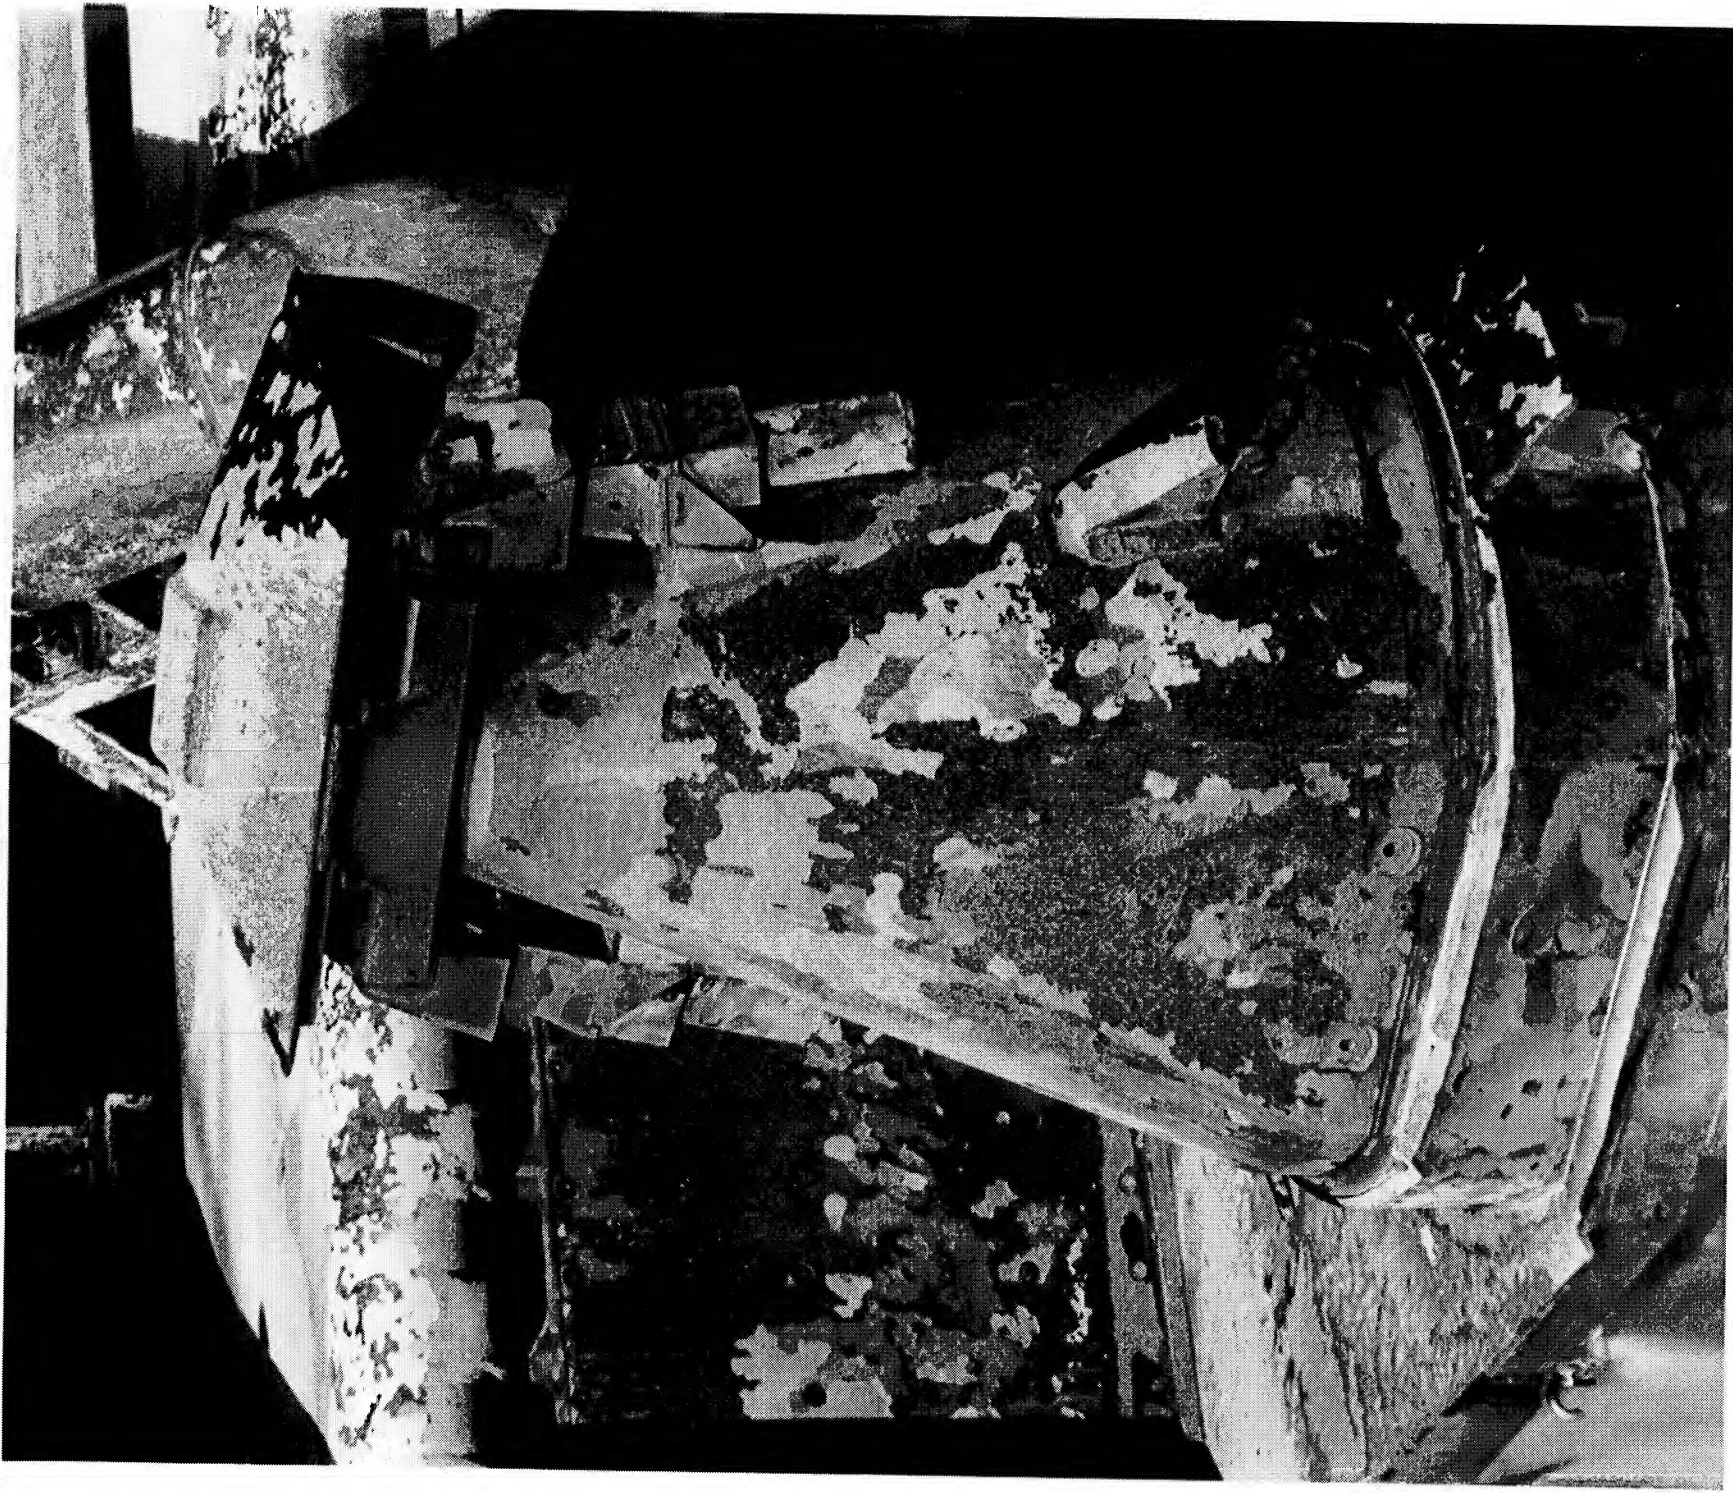
Post launch condition of a north SRB holddown post. All holddown post doghouse blast covers were closed.

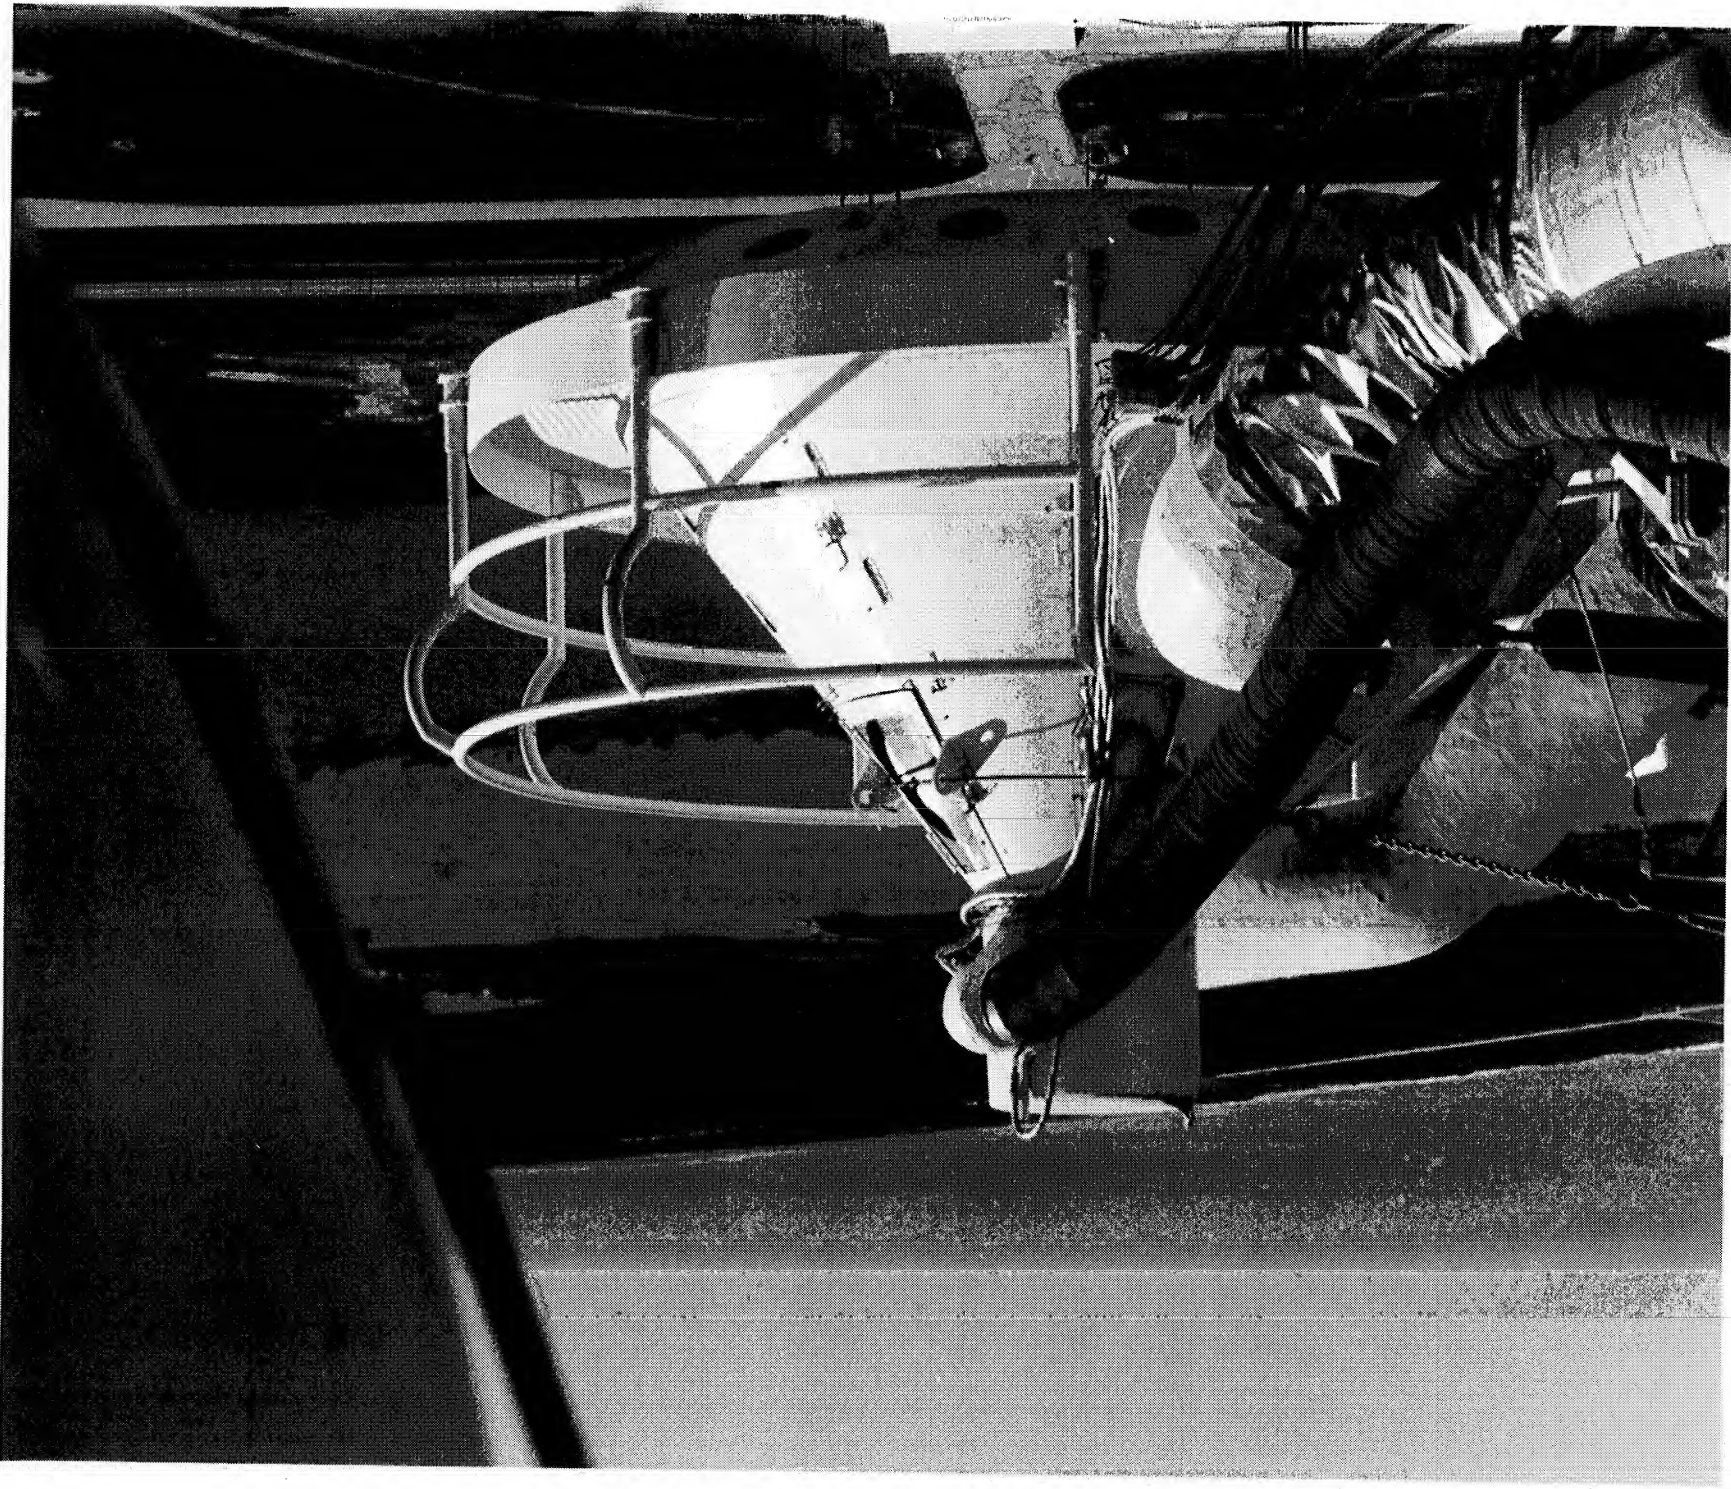
The GOX vent hood sustained launch damage in the form of a broken window and torn insulation on the plenum chamber

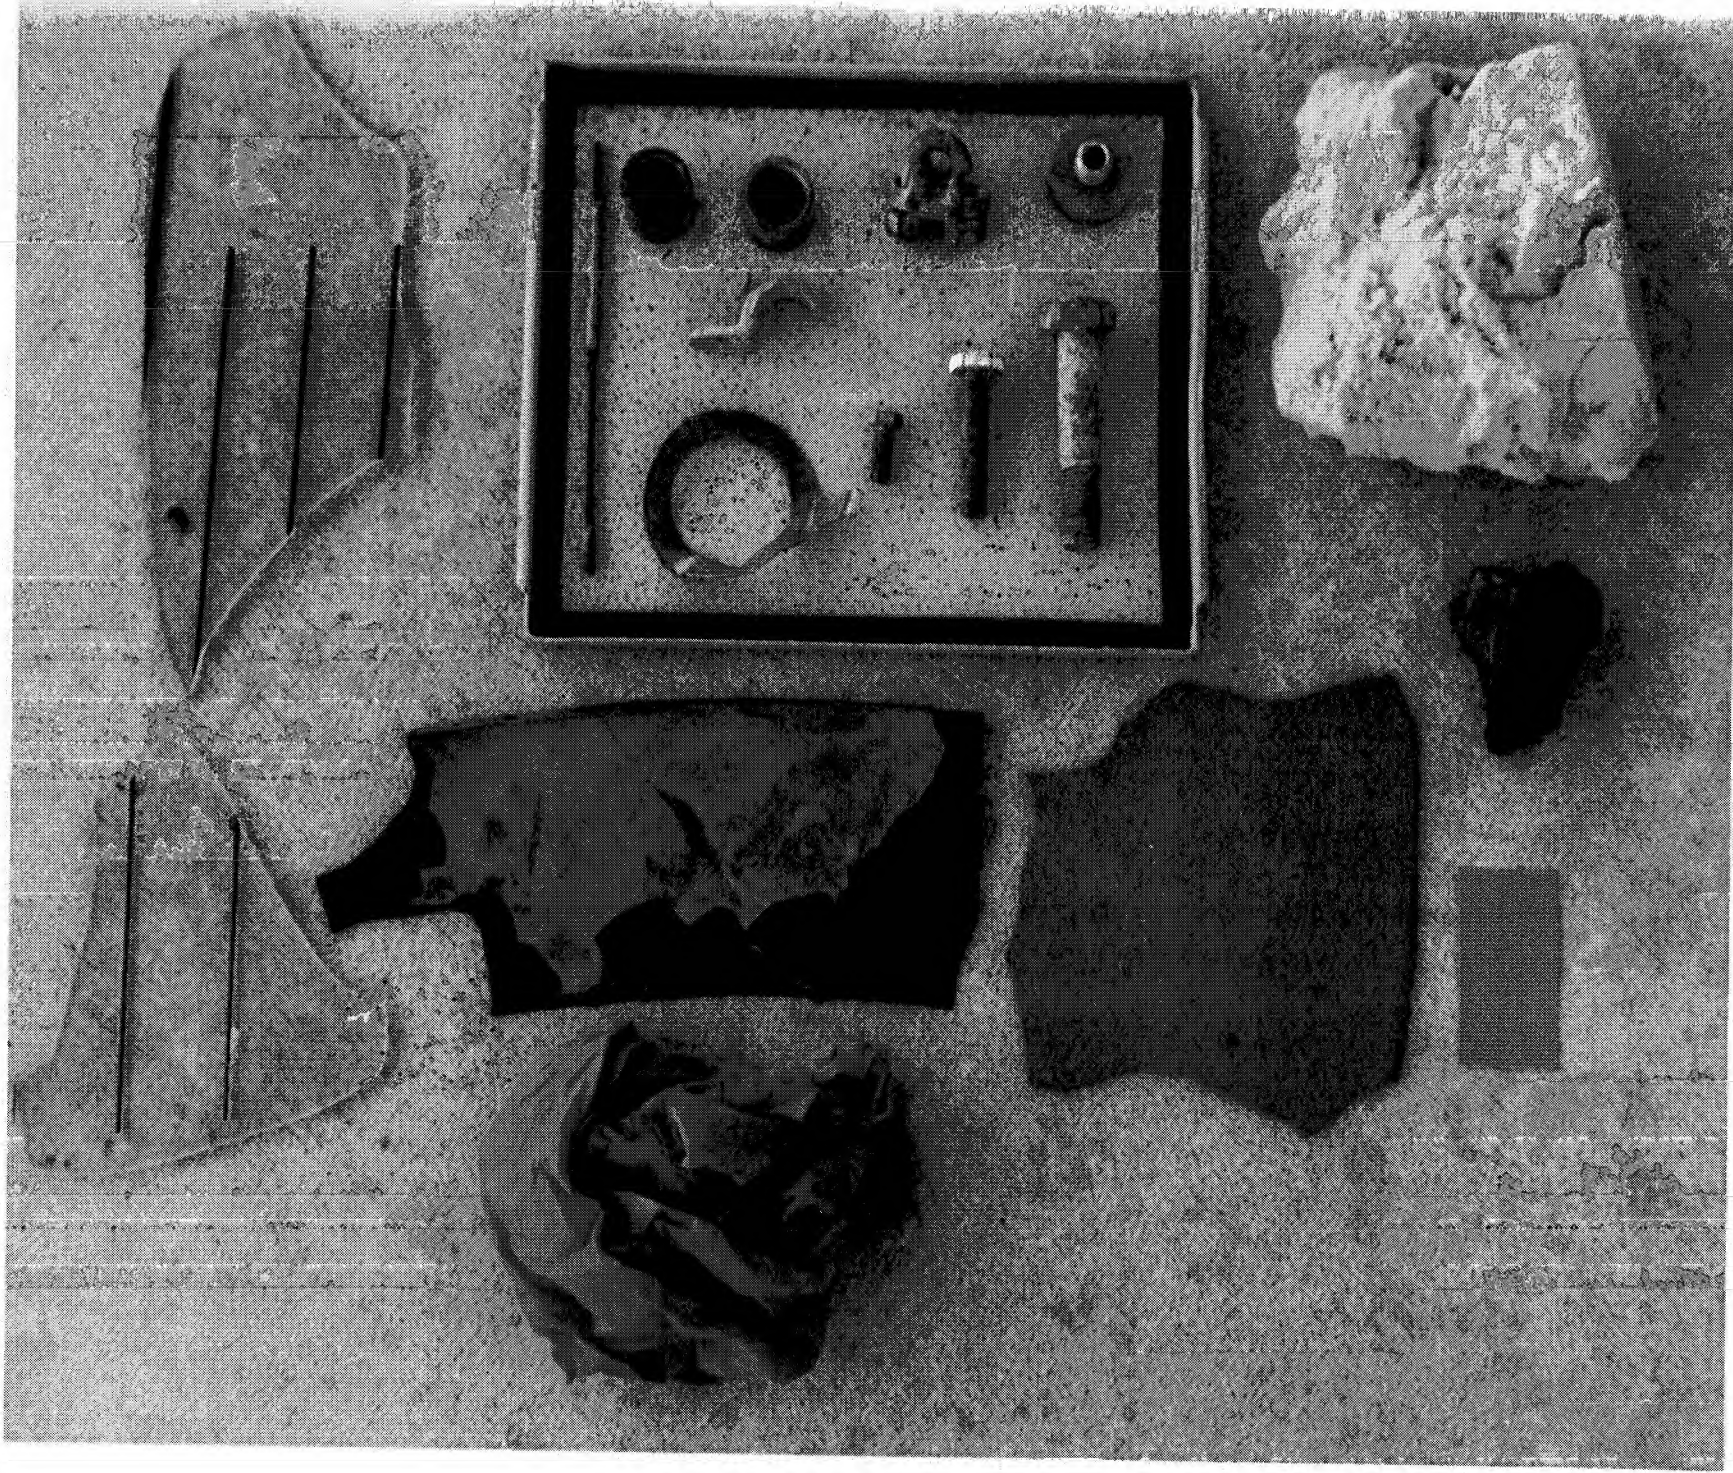
Typical debris recovered after launch. Note orange GSE tile shim and pieces of window from the GOX vent hood.

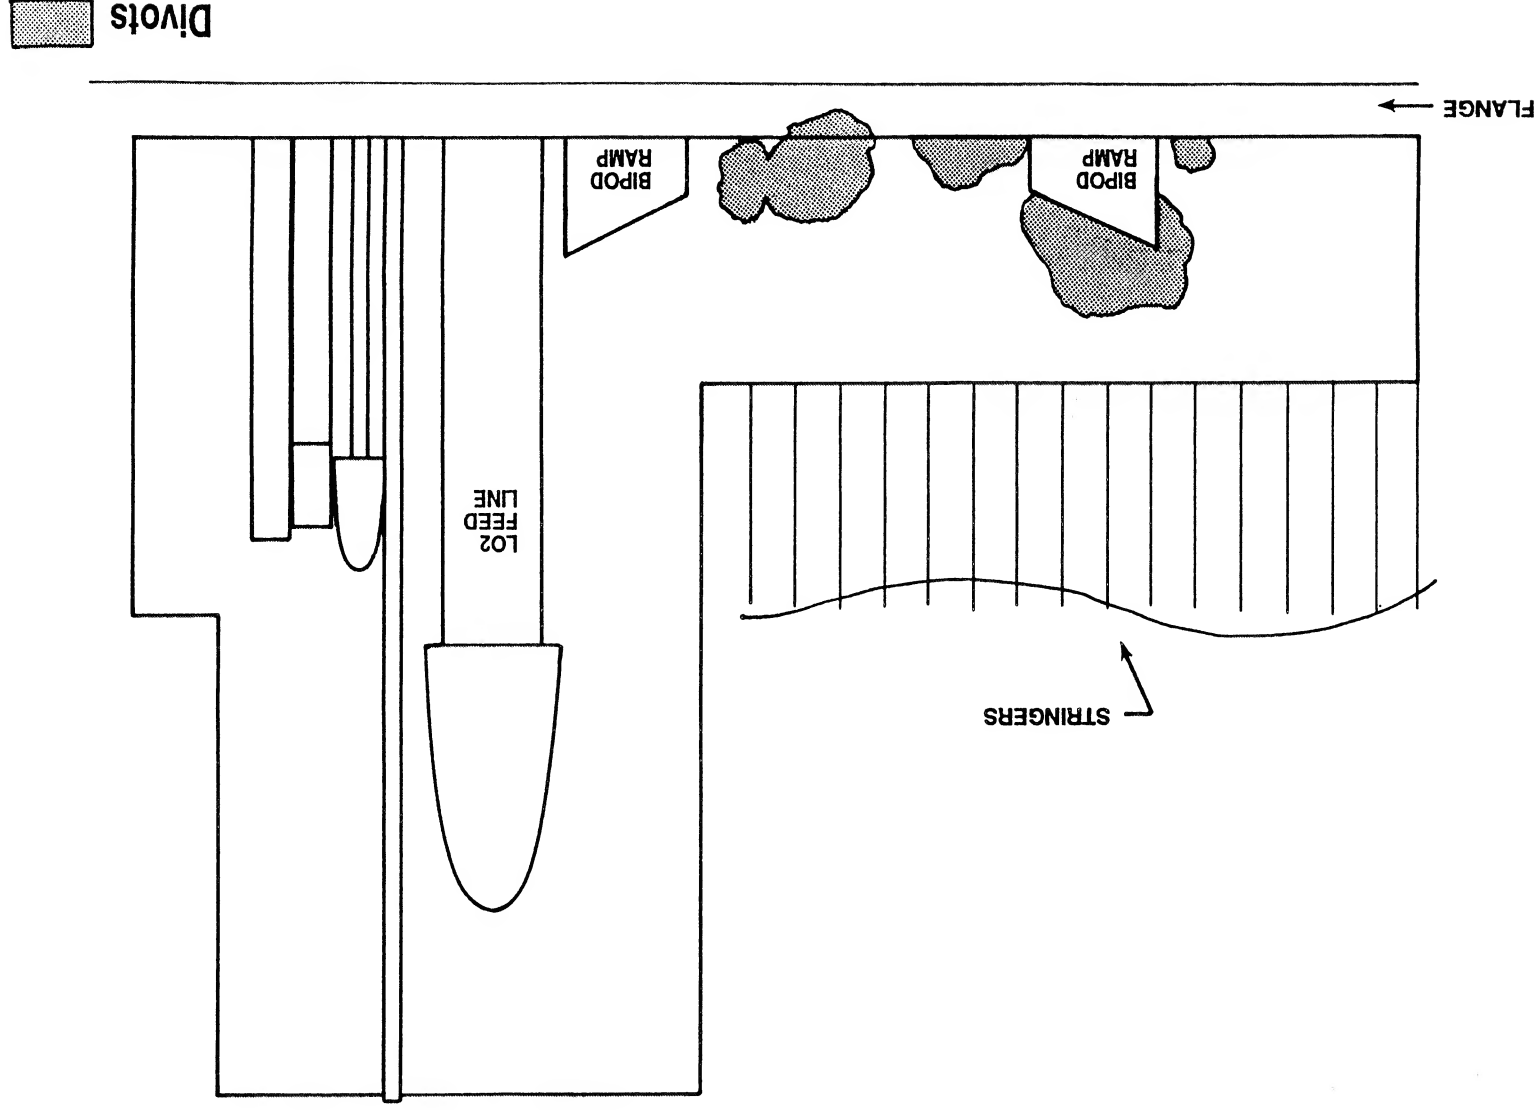
FIGURE 13. STS-32R IN-FLIGHT ANOMALY (STS-32-T-1)  
Missing Intertank TPS Shown on Post Separation Photos

forward part of the LH bipod ramp. Stringers were visible in the divots indicating a depth greater than the isochem line. A fifth divot measuring 6 inches in diameter was located outboard of the LH bipod ramp and just above the LH2 tank splice. The LH2 tank acreage was in good condition with the exception of 2 divots, one of which was a repair, in the spray abort areas. Four large pieces of ET TPS appeared from behind the umbilical cable tray or fell aft into the field of view. These foam pieces were the divots from the intertank area. The top of the LH2 umbilical was damaged and covered with frozen hydrogen. The LO2 umbilical was in good condition with the exception of ice or a thin layer of TPS peeled back on top of the umbilical.

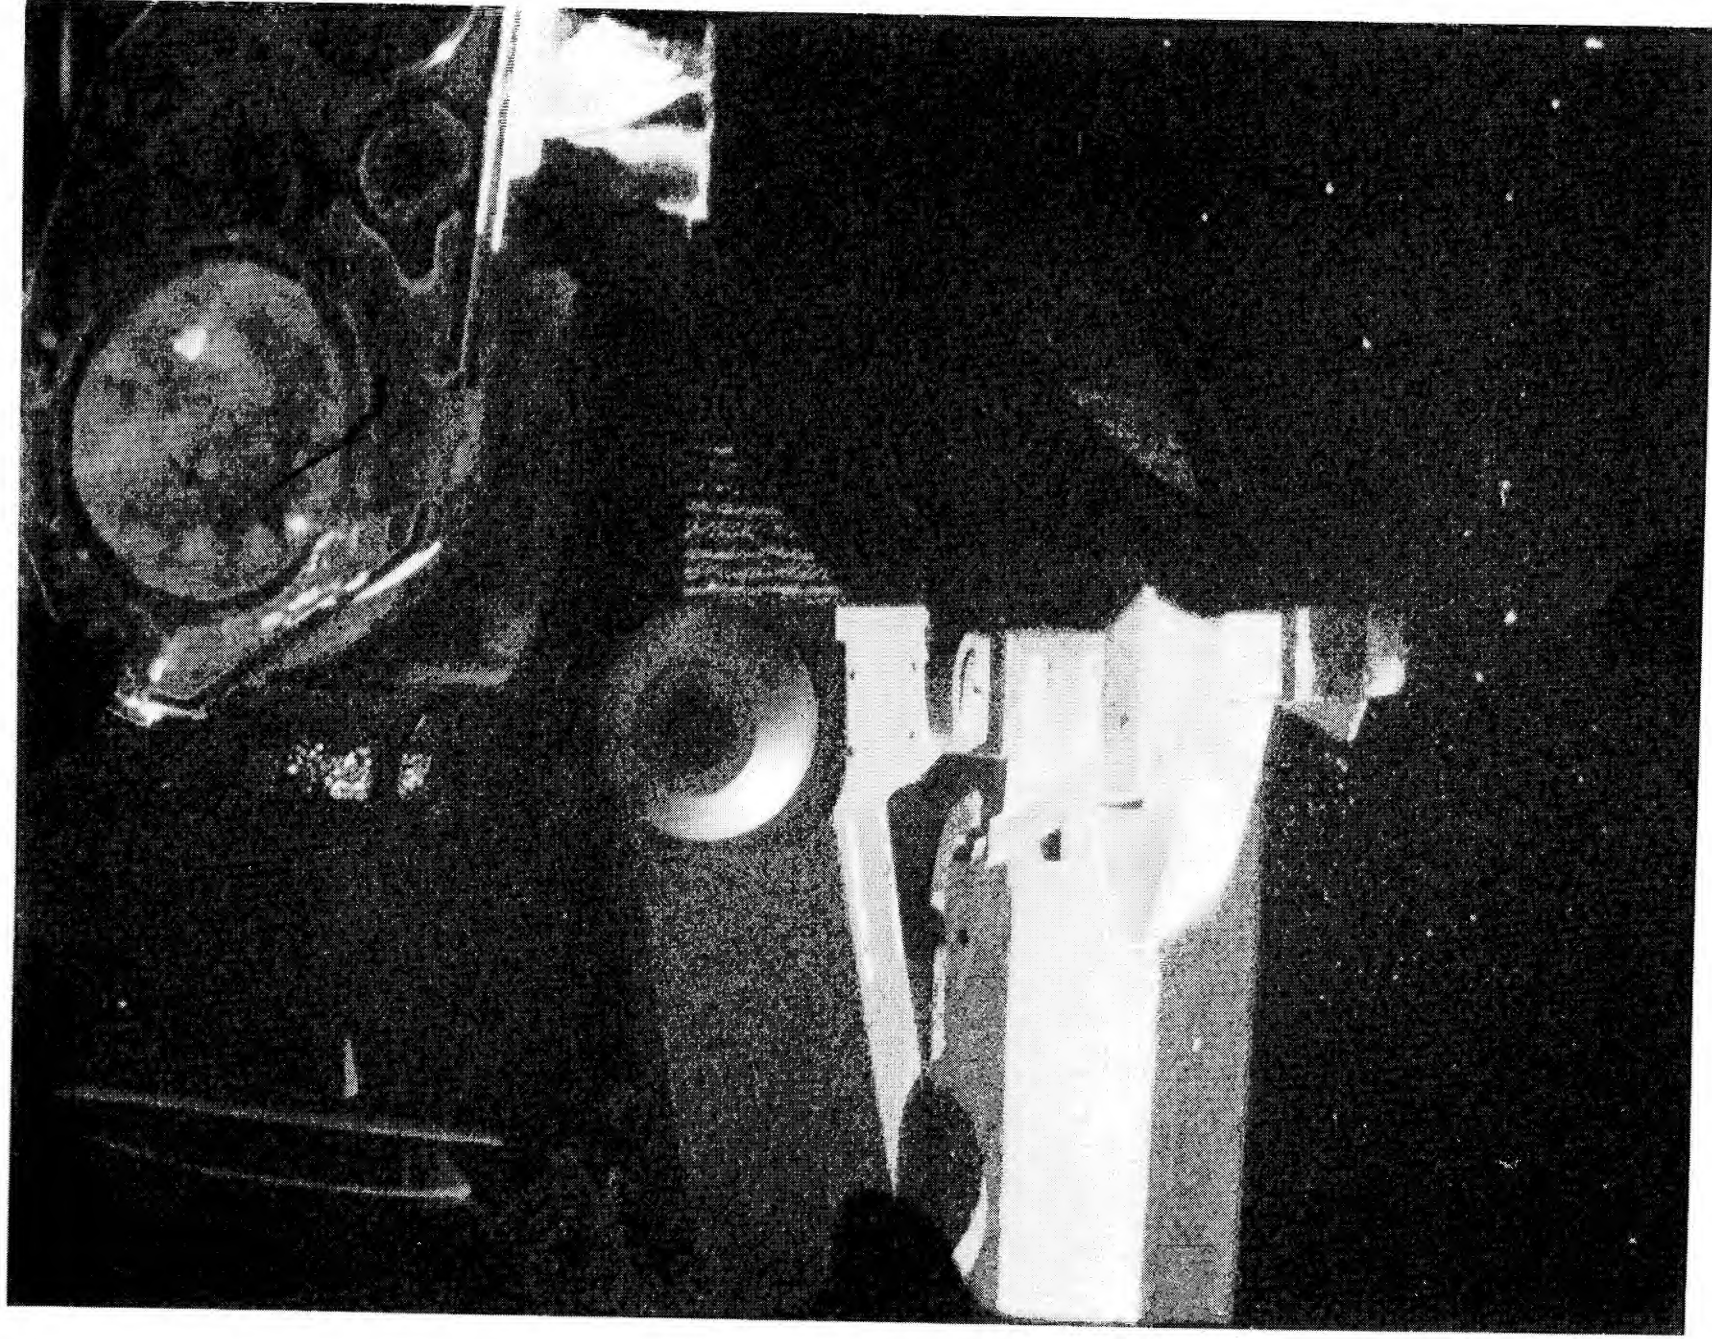
LH2 17-inch flapper valve is filled with frozen hydrogen. Top left area of umbilical is damaged/covered by frozen hydrogen.

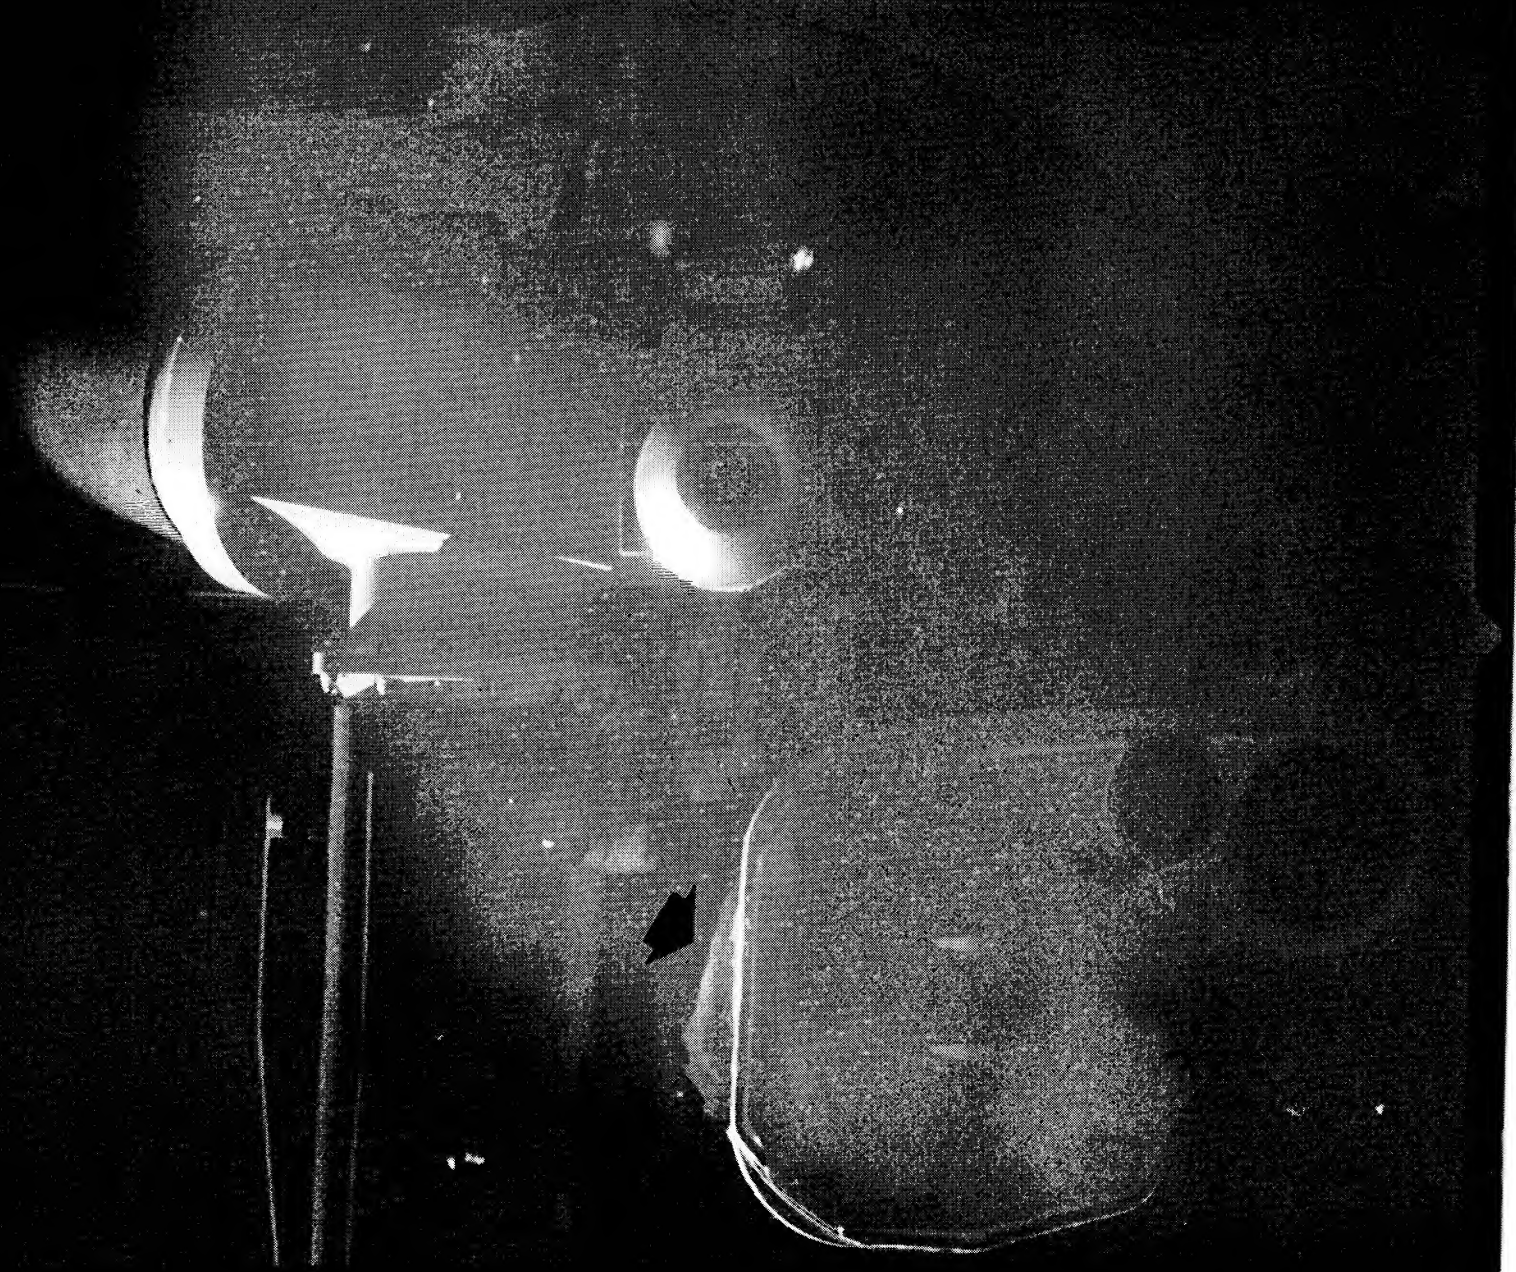
Very little damage is visible on +Y side of ET except for TPS  
peeled back or ice covering on top side of LO2 umbilical

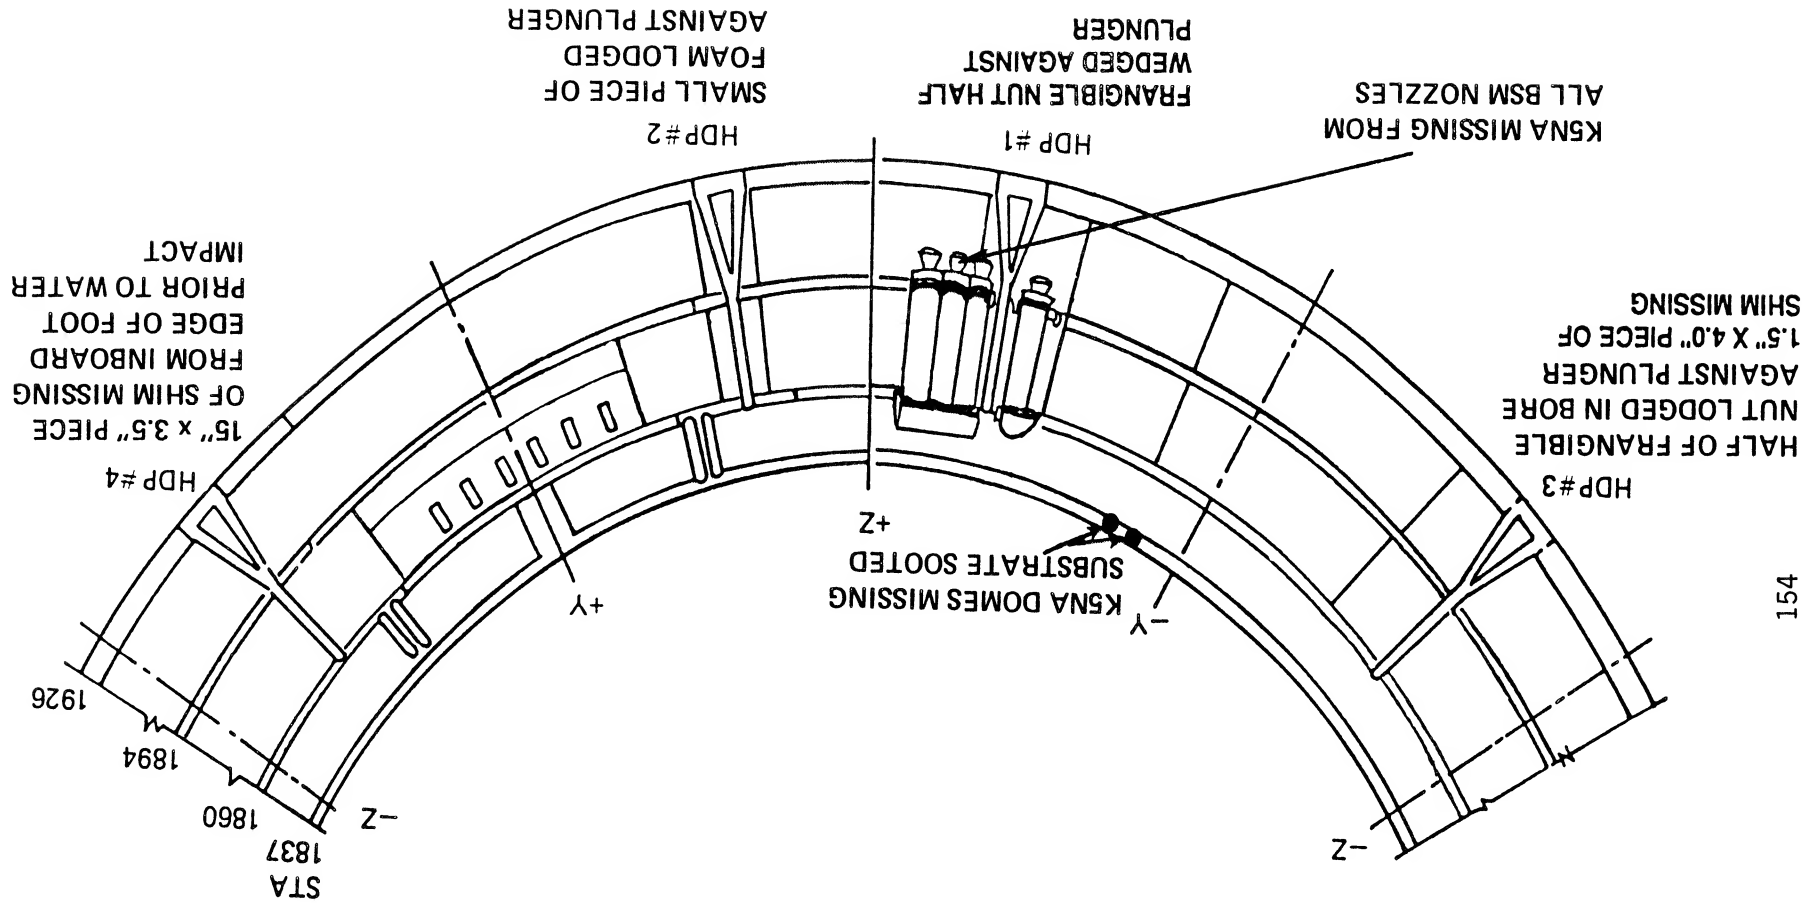
FIGURE 16. RIGHT SRB AFT SKIRT EXTERIOR TPS

The TPS over the aft skirt acreage was generally in good condition (Figure 16). The TVC system appeared to be undamaged. Instafoam was missing from the aft ring around the aft skirt feet, HPU exhaust horns, and joint heater umbilical.
